**FINAL REPORT**

**“GEOTECHNICAL DRILLINGS  
ATACAMA COSMOLOGY TELESCOPE”**

**EARTH SCIENCE CONSULTANTS**

**GEOTECHNICAL REPORT**  
**ROCK SUSTRATUM FOR RADIO TELESCOPE FOUNDATION**  
**ATACAMA COSMOLOGY TELESCOPE PROJECT**

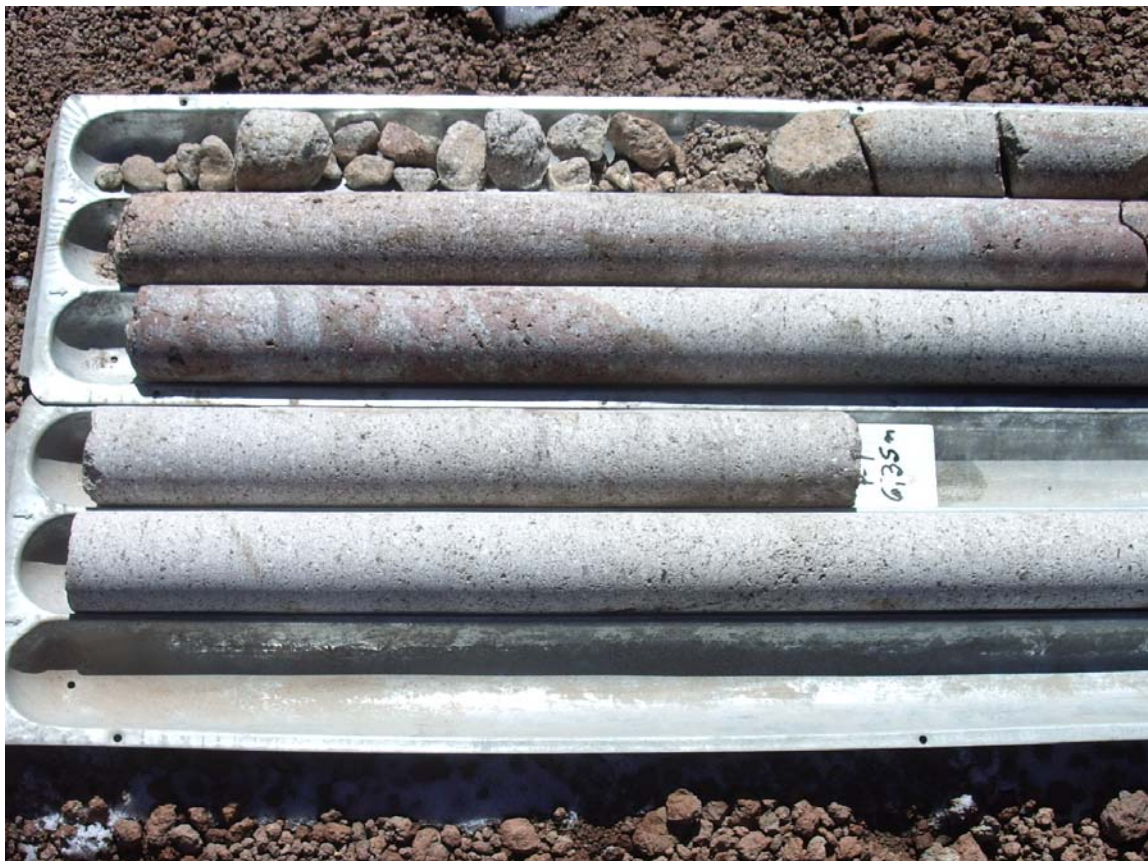
##### 3.1.1 Photography “Rock Samples” – Perforation P-1

| Section (m) | | Drilled (m) | Recovered (m) | FF | RQD |
|---|---|---|---|---|---|
| 3,35 | 3,92 | 0,57 | 0,37 | >n | 0% |

| 0.00 – 2.80 m | Level of overload and corresponds to fractured blocks filled with sand and gravel that is mostly of dacitic composition. |
| 2.80 – 3.92 m | Dacitic lava, rock with fractures, and has a light grey color; the degree of crystallinity corresponds to an effusive rock (Hipocrystalline) and has a phaneritic texture and medium grain size. |
| 3.92 – 7.85 m | Dacitic lava, rock without fractures and has a light grey color; the degree of crystallinity corresponds to an effusive rock (Hipocrystalline) and has a phaneritic texture and medium grain size. |

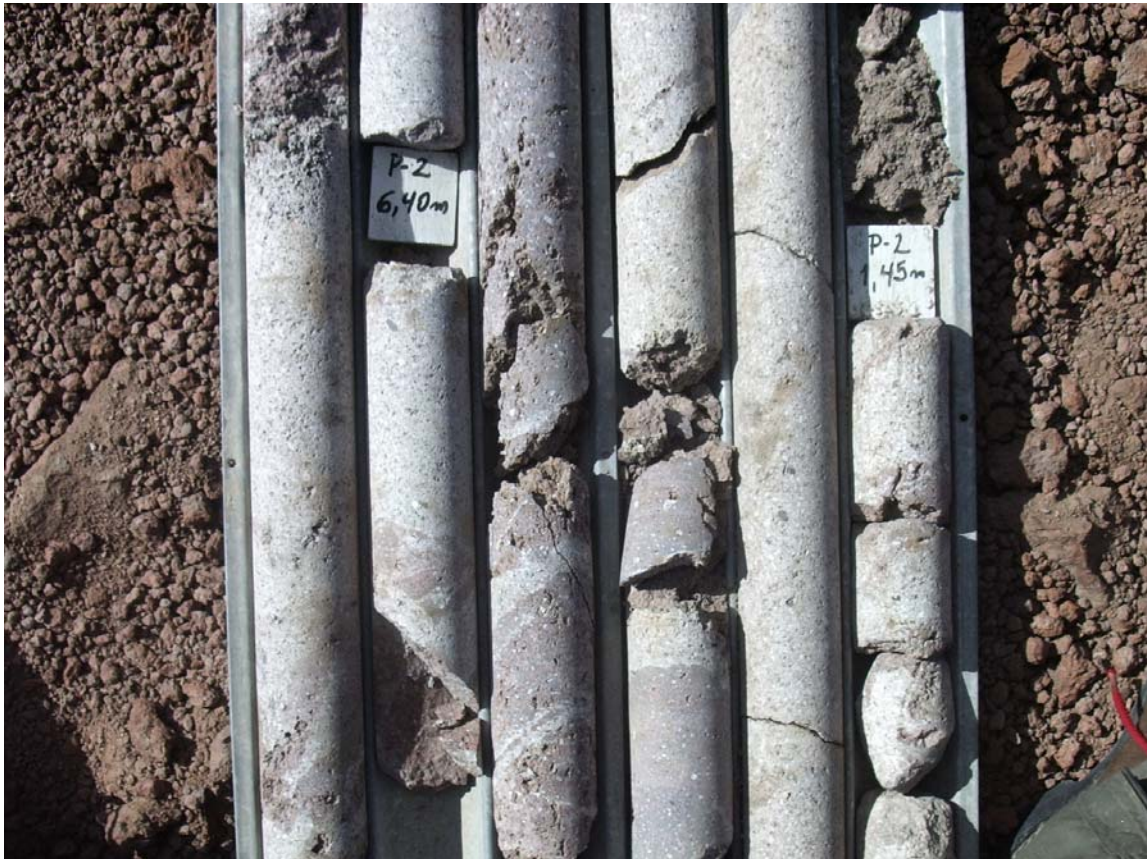
### 3.2.1 Photography “Rock Samples” – Perforation P-2

- 0.00 – 1.45 m      Level of overload and corresponds to fractured blocks filled with sand and gravel that is mostly of dacitic composition.
- 1.45 – 2.20 m      Dacitic lava, rock with fractures, and has a light grey color; the degree of crystallinity corresponds to an effusive rock (Hipocrystalline) and has a phaneritic texture and medium grain size.
- 2.20 – 7.85 m      Dacitic lava with an andesitic pattern; light grey color in dark sections, with a reddish orientation; the degree of crystallinity corresponds to an effusive rock (Hipocrystalline), of phaneritic texture and with a medium grain size. The rock has a lot of fractures with a pumiced filling that is highly permeable.

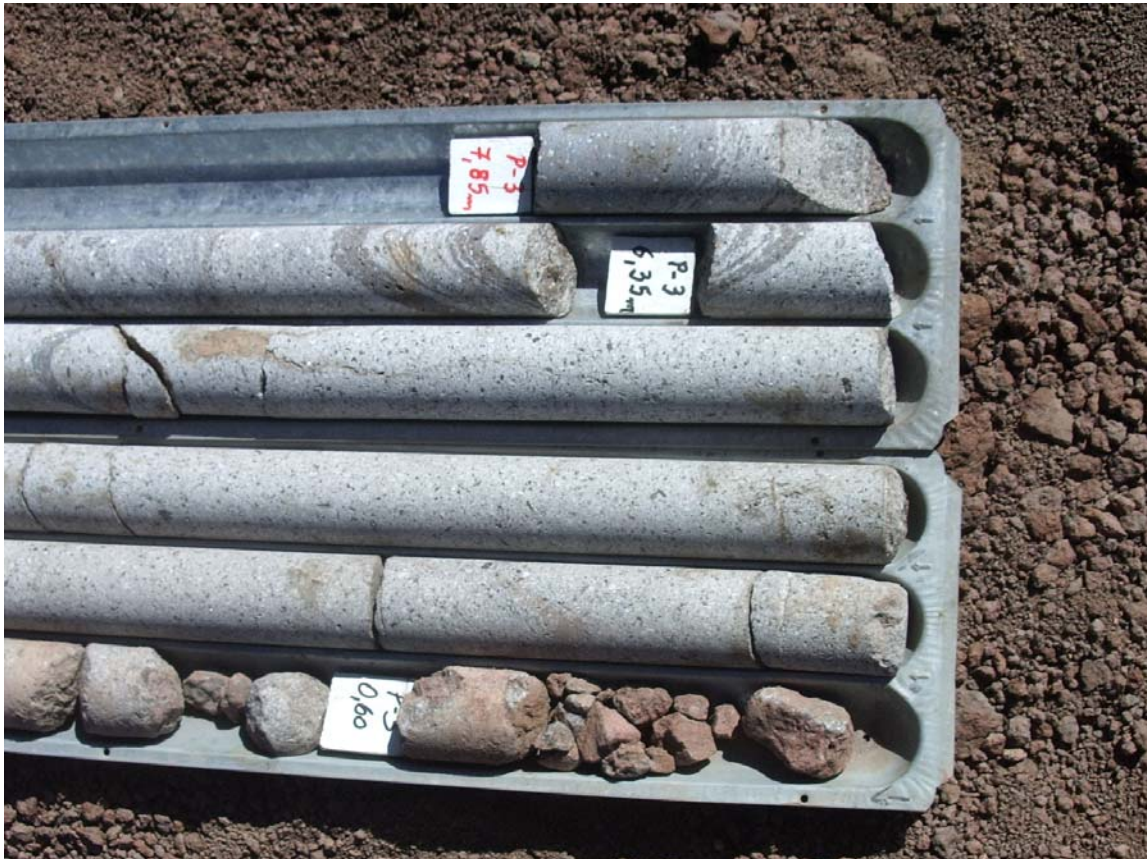
#### 3.3.1 Photography “Rock Samples” – Perforation P-3

| 0.00 – 1.40 m | Level of overload and corresponds to fractured blocks filled with sand and gravel that is mostly of dacitic composition. |
| 1.40 – 2.05 m | Dacitic lava, rock with fractures, and has a light grey color; the degree of crystallinity corresponds to an effusive rock (Hipocrystalline) and has a phaneritic texture and medium grain size. |
| 2.05 – 7.85 m | Dacitic lava with an andesitic pattern light grey color in dark sections, with a reddish orientation; the degree of crystallinity corresponds to an effusive rock (Hipocrystalline), of phaneritic texture and with a medium grain size. The rock presents horizontal and vertical fractures. |

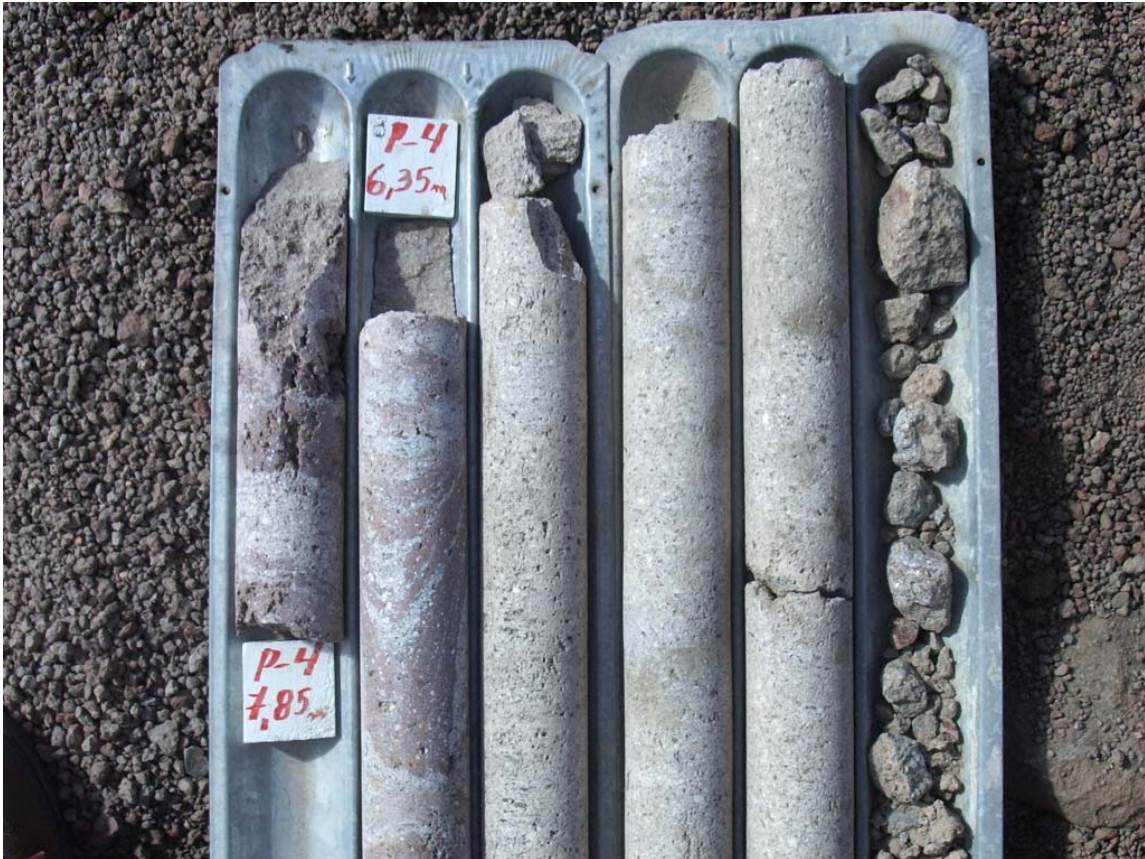
#### 3.4.1 Photography “Rock Samples” – Perforation P-4

- 0.00 – 1.20 m      Level of overload and corresponds to fractured blocks filled with sand and gravel that is mostly of dacitic composition.
- 1.20 – 1.60 m      Dacitic lava, rock with fractures, and has a light grey color; the degree of crystallinity corresponds to an effusive rock (Hipocrystalline) and has a phaneritic texture and medium grain size.
- 1.60 – 7.85 m      Dacitic lava, light grey color, with a reddish orientation; the degree of crystallinity corresponds to an effusive rock (Hipocrystalline), of phaneritic texture and with a medium grain size. The rock presents horizontal and vertical fractures.

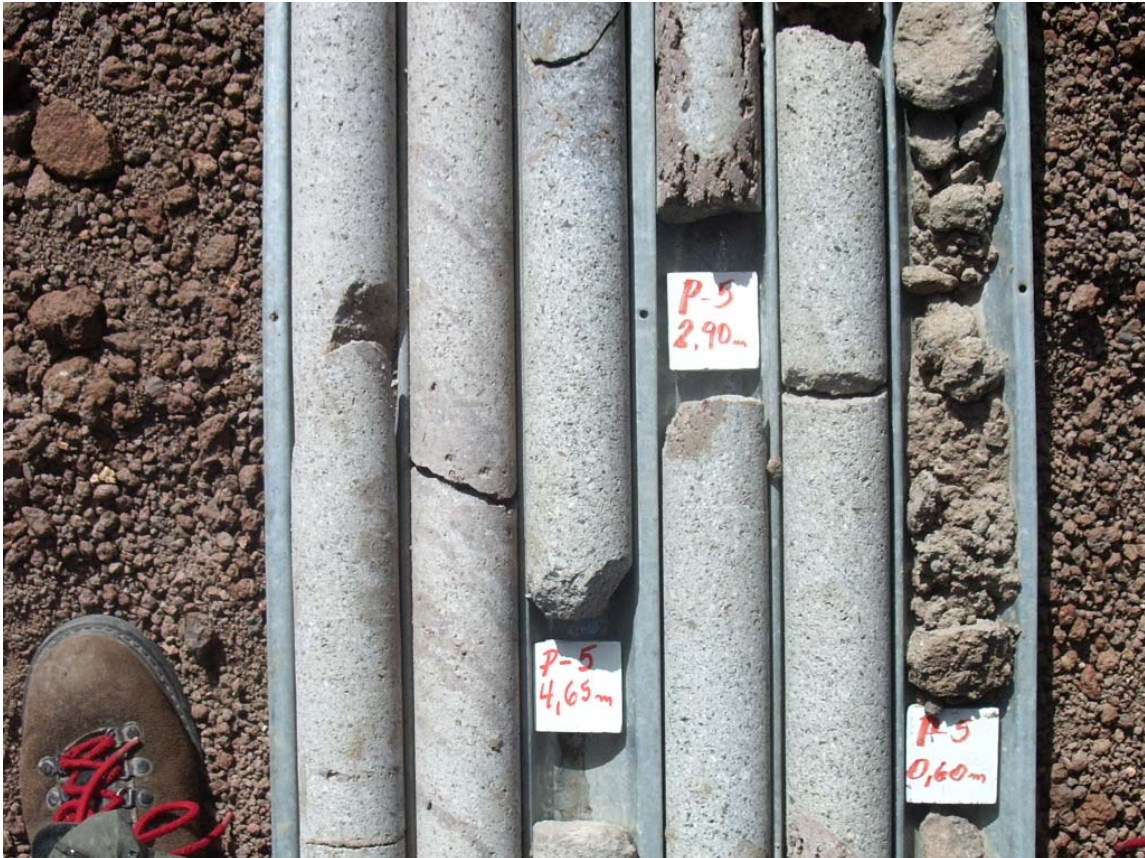
#### 3.5.1 Photography “Rock Samples” – Perforation P-5

- 0.00 – 0,60 m      Level of overload and corresponds to fractured blocks filled with sand and gravel that is mostly of dacitic composition.
- 0.60 – 1.40 m      Dacitic lava, rock with fractures, and has a light grey color; the degree of crystallinity corresponds to an effusive rock (Hipocrystalline) and has a phaneritic texture and medium grain size.
- 1.40 – 7.80 m      Dacitic lava with an andesitic pattern; light grey color in dark sections, with a reddish orientation; the degree of crystallinity corresponds to an effusive rock (Hipocrystalline), of phaneritic texture and with a medium grain size. The rock presents horizontal and vertical fractures. In some sections has a pumiced filling.

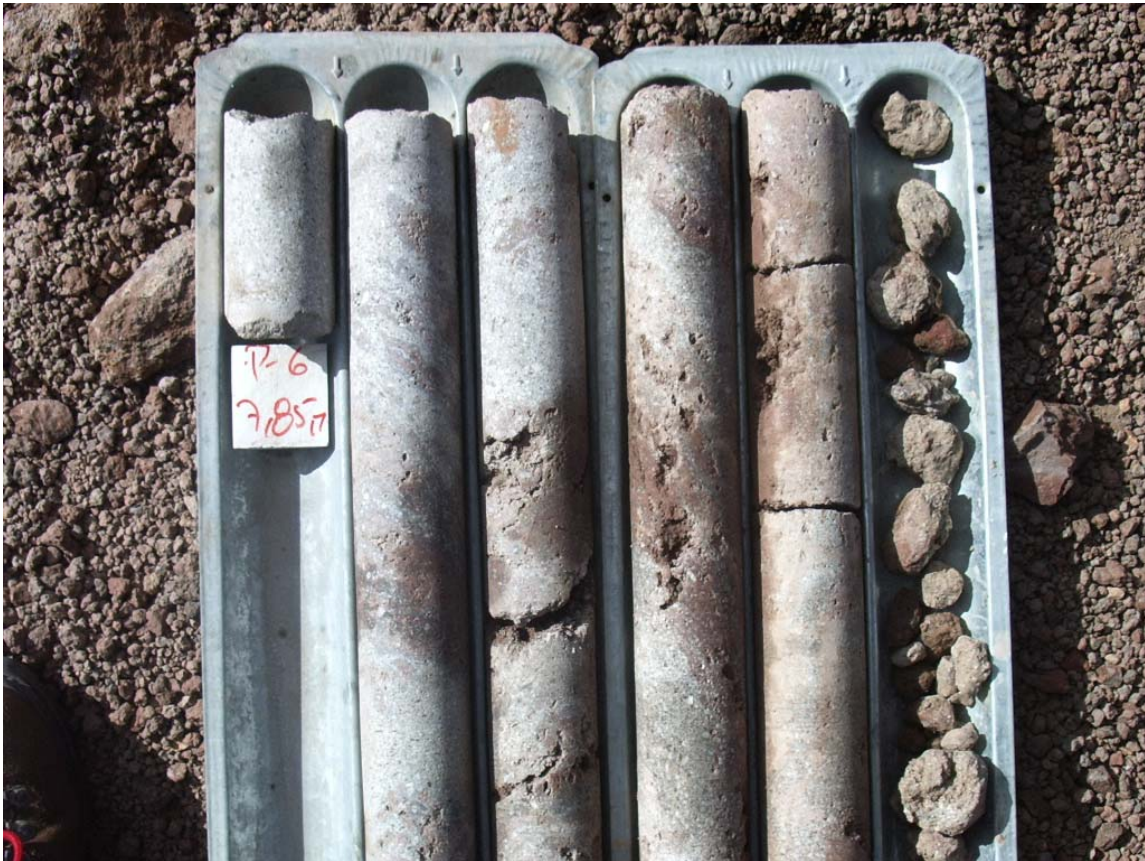
#### 3.6.1 Photography “Rock Samples” – Perforation P-6

| 0.00 – 1.20 m | Level of overload and corresponds to fractured blocks filled with sand and gravel that is mostly of dacitic composition. |
| 1.20 – 1.40 m | Dacitic lava, rock with fractures, and has a light grey color; the degree of crystallinity corresponds to an effusive rock (Hipocrystalline) and has a phaneritic texture and medium grain size. |
| 1.40 – 7.85 m | Dacitic lava with an andesitic pattern; light grey color in dark sections, with a reddish orientation; the degree of crystallinity corresponds to an effusive rock (Hipocrystalline), of phaneritic texture and with a medium grain size. The rock has a lot of fractures with a pumiced filling that is highly permeable |

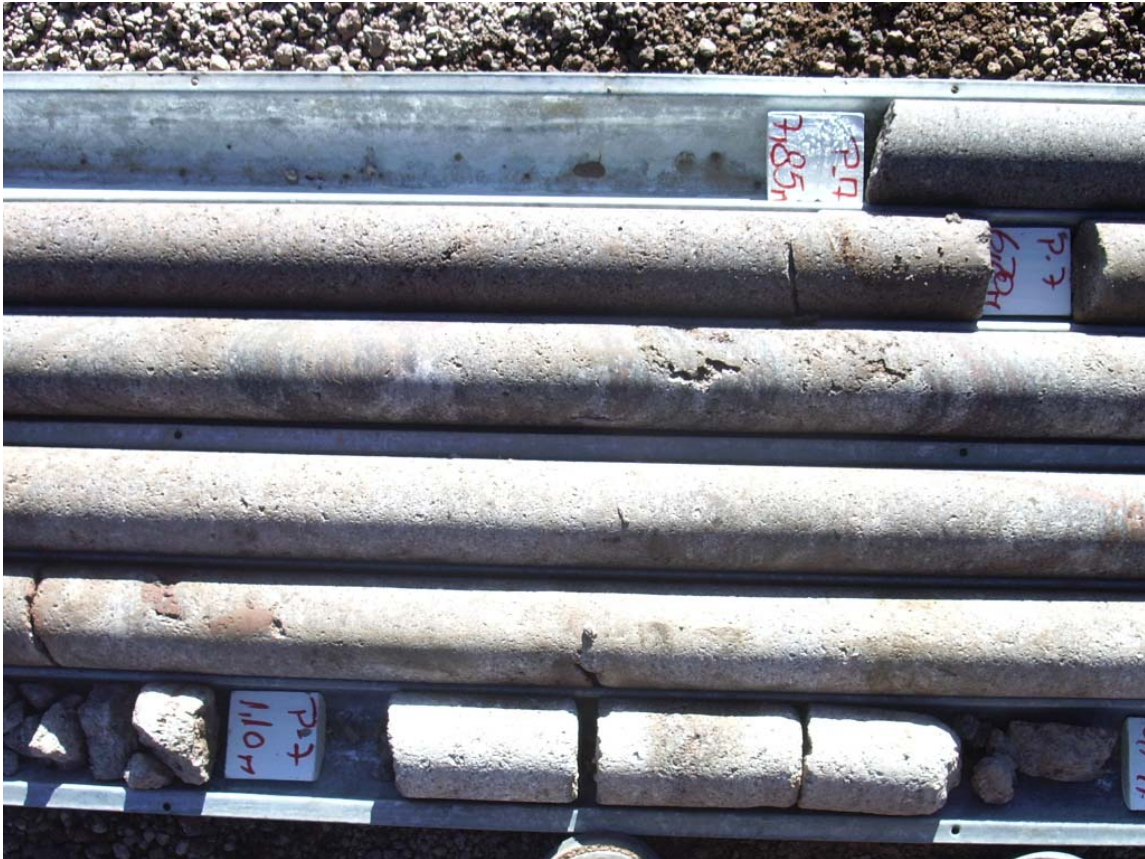
#### 3.7.1 Photography “Rock Samples” – Perforation P-7

| 0.00 – 0.70 m | Level of overload and corresponds to fractured blocks filled with sand and gravel that is mostly of dacitic composition. |
| 0.70 – 1.55 m | Dacitic lava, rock with fractures, and has a light grey color; the degree of crystallinity corresponds to an effusive rock (Hipocrystalline) and has a phaneritic texture and medium grain size. |
| 1.55 – 7.85 m | Dacitic lava; light grey color with a reddish orientation; the degree of crystallinity corresponds to an effusive rock (Hipocrystalline), of phaneritic texture and with a medium grain size. The rock presents horizontal and vertical fractures. |

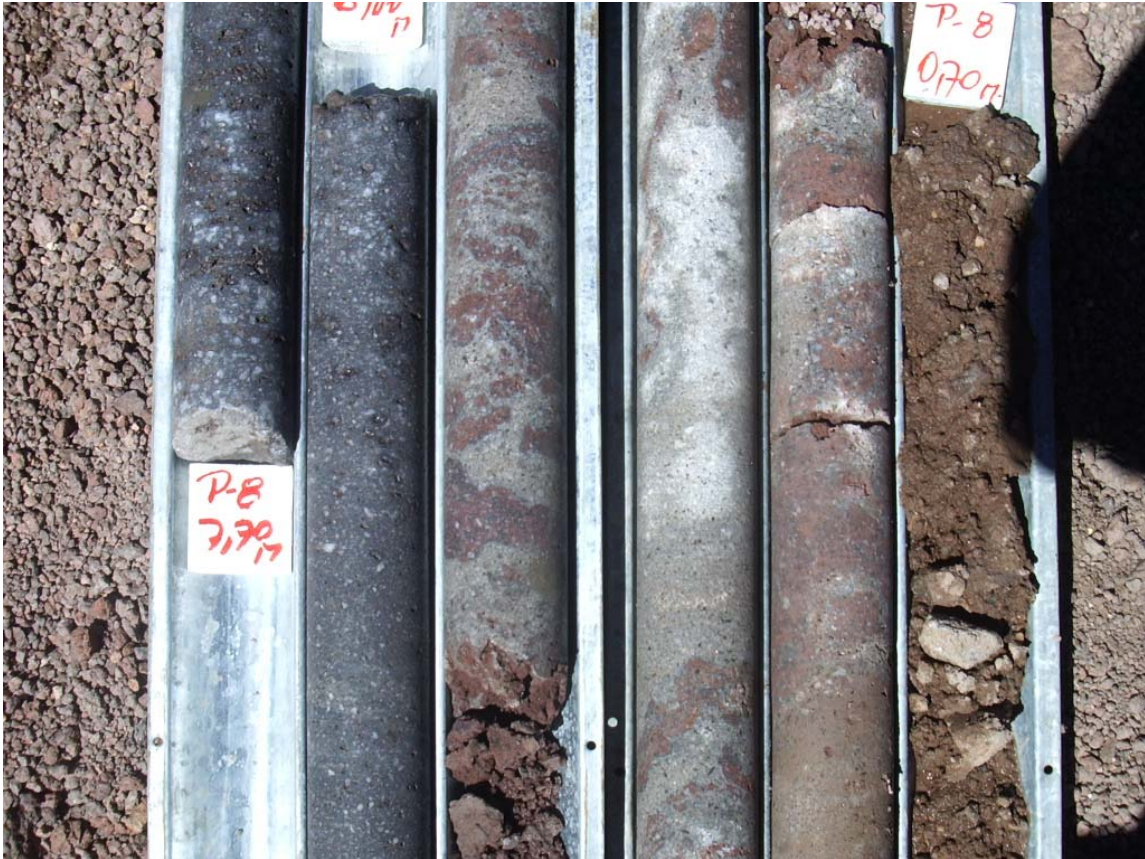
#### 3.8.1 Photography “Rock Samples” – Perforation P-8

| 0,00 – 1,70 m | Level of overload and corresponds to fractured blocks filled with sand and gravel that is mostly of dacitic composition |
| 1,70 – 2,40 m | Dacitic lava, rock with fractures, and has a light grey color; the degree of crystallinity corresponds to an effusive rock (Hipocrystalline) and has a phaneritic texture and medium grain size. |
| 2,40 – 7,70 m | Dacitic lava with an andesitic pattern; light grey color, with a reddish orientation; the degree of crystallinity corresponds to an effusive rock (Hipocrystalline), of phaneritic texture and with a medium grain size. The rock presents horizontal and vertical fractures. Some inferior sections have fractures with a pumiced filling. |

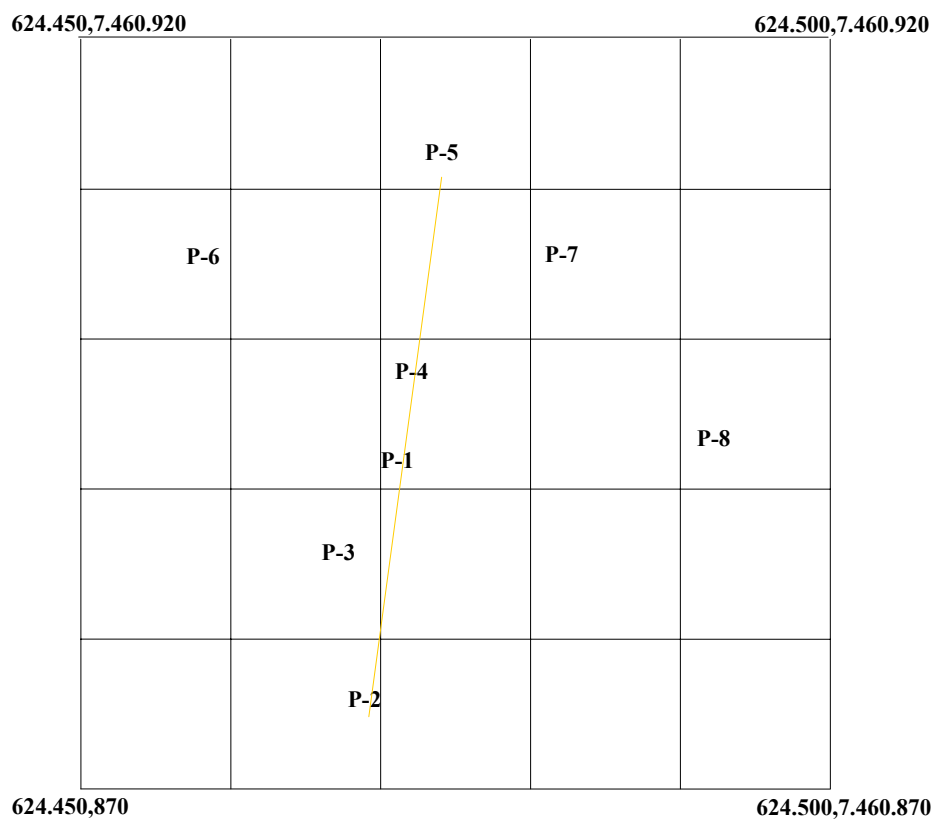
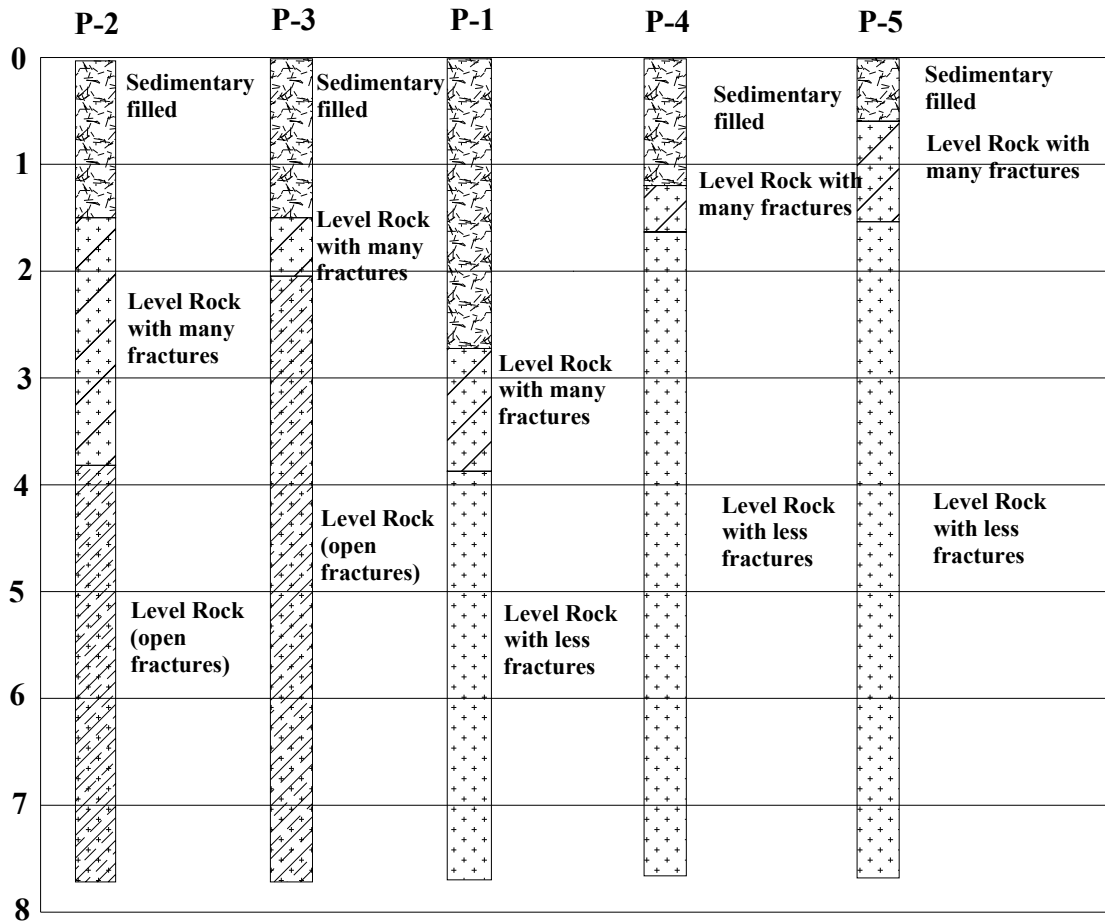
#### IV. PROFILE P-2 to P-5

- Massive rock it is found at a deep average of 1.4 meters (toward sector of perforations P-4, P-5, P-6 and P-7). Massive rock quality in situ =>80 (good quality rock)

For perforations P-1, P-2, P-3 and P-8, massive rock quality in situ is also good, but it is found deeper under 2.20 meters as an average.

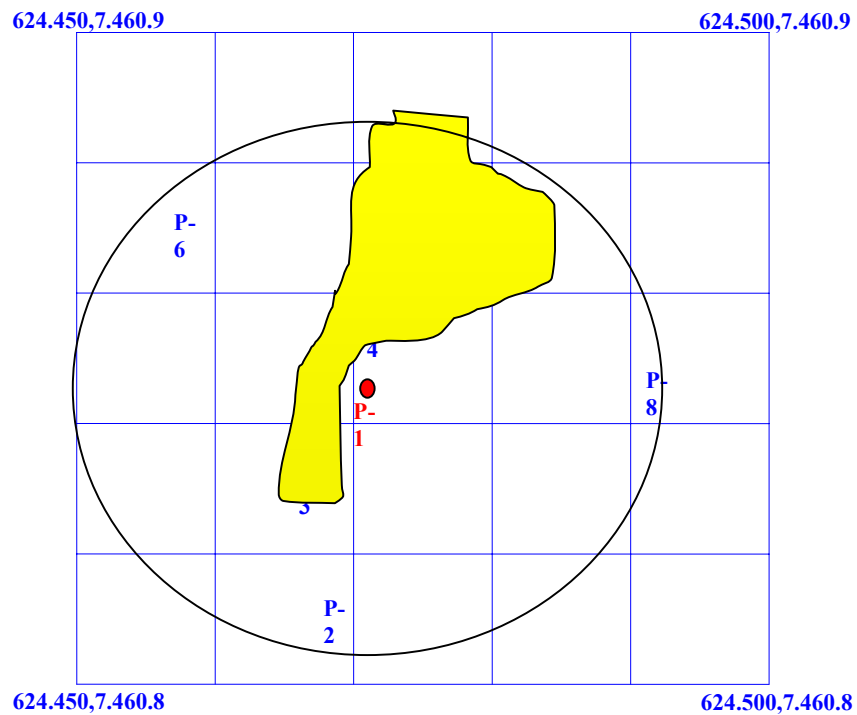
According to results of drillings and its deep (aprox 7,85m) it is clearly possible to state that rock layer with best quality conditions in terms of hardness and lack of fractures was found at line of perforations given by P-3; P-4; P-5 and P-7.

- Plan any work in direction of the axes formed by perforations P-3; P-4; P-5 and P-7 as shown by the following scheme:
