**FINAL REPORT**

**“GEOTECHNICAL DRILLINGS  
ATACAMA COSMOLOGY TELESCOPE”**

**EARTH SCIENCE CONSULTANTS**

**GEOTECHNICAL REPORT**  
**ROCK SUSTRATUM FOR RADIO TELESCOPE FOUNDATION**  
**ATACAMA COSMOLOGY TELESCOPE PROJECT**

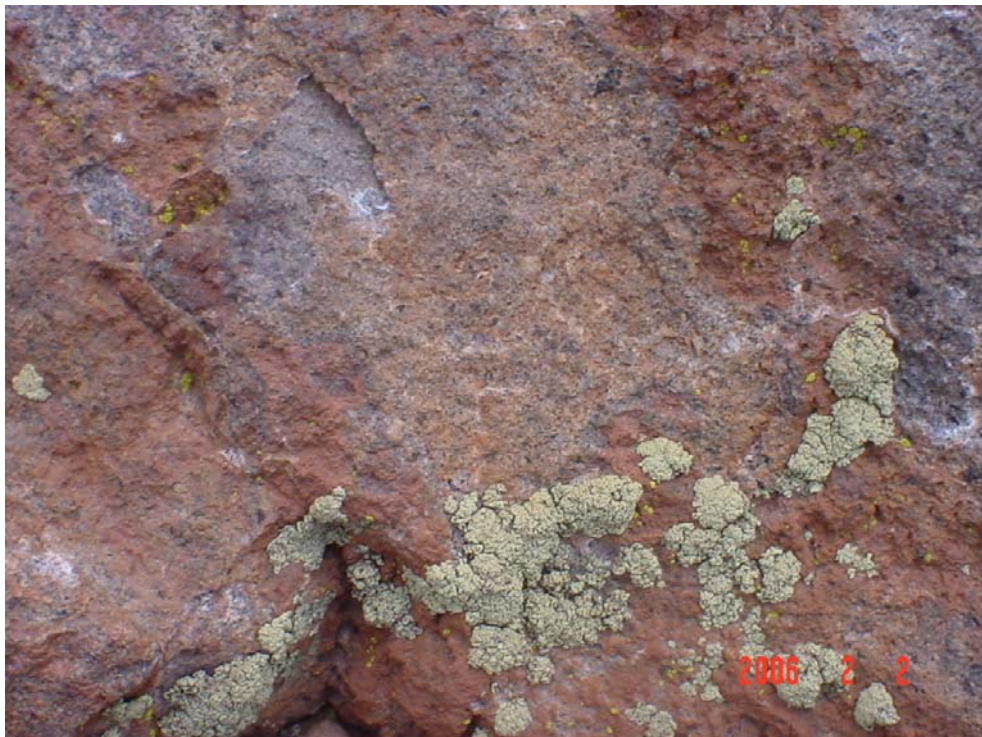
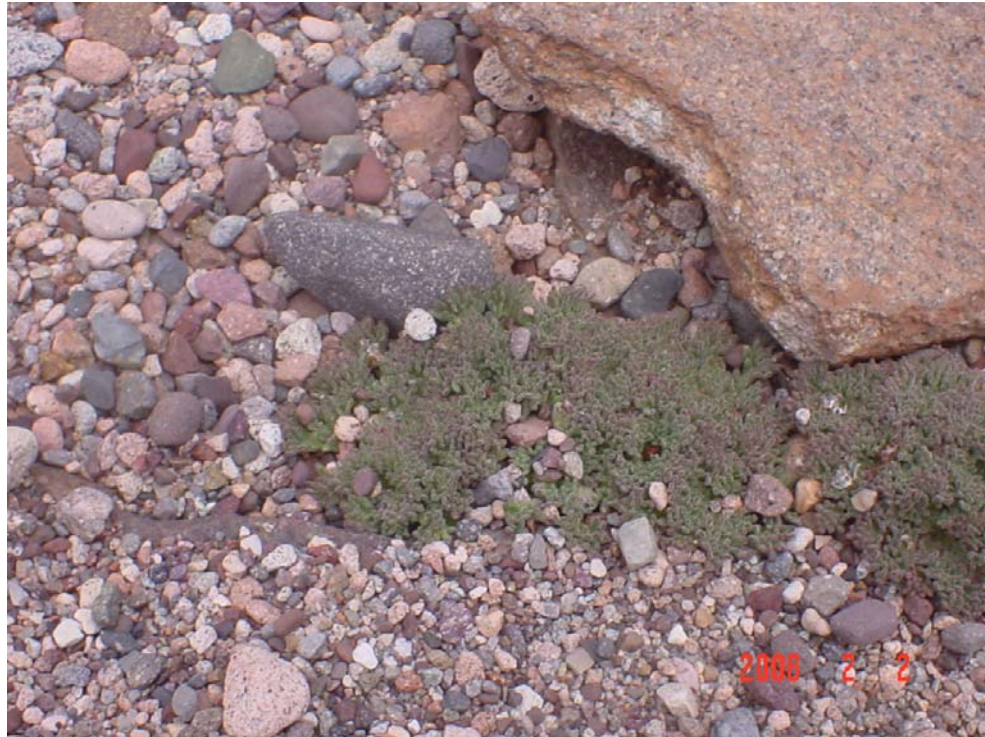
- The site nearly lacks all forms of vegetation except for minor species and lichens spread out scarcely as is shown in the following photographs:

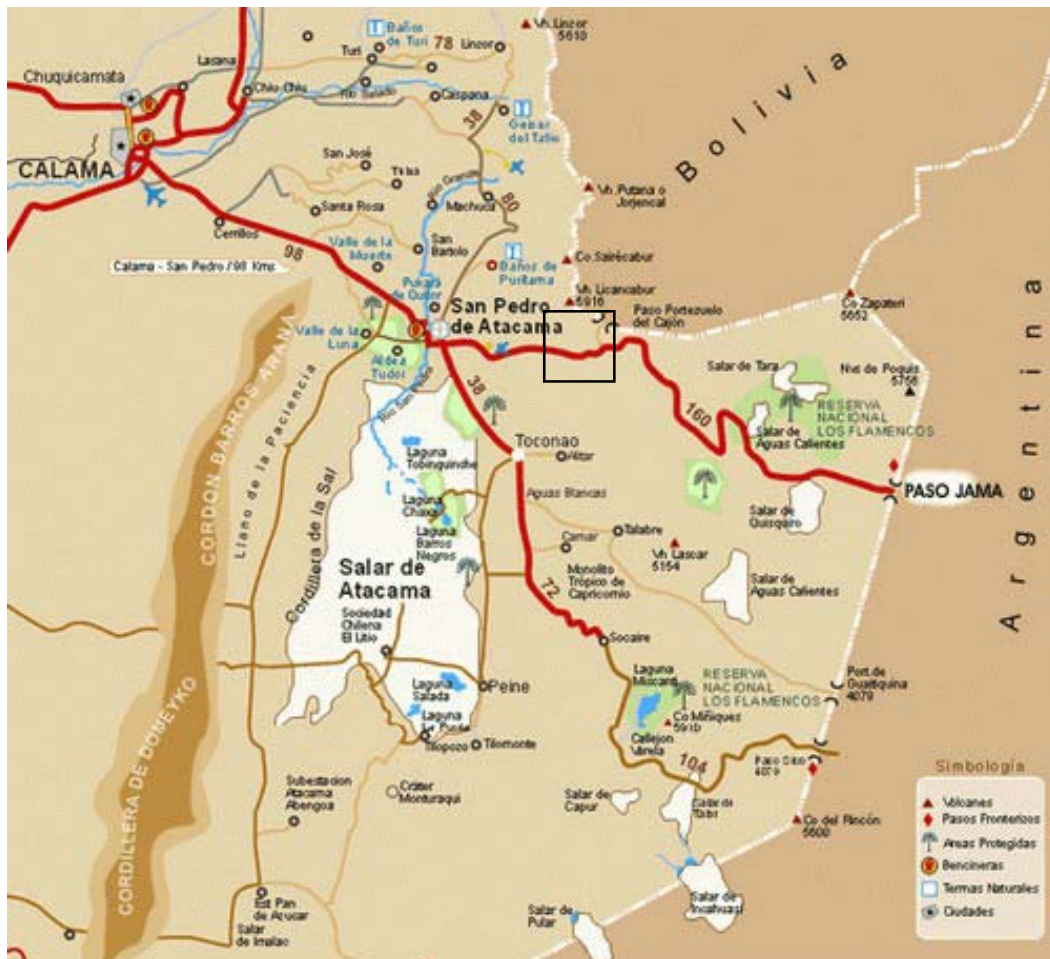
Image N°1: General location of the project

The site where the geotechnical drillings took place is located in San Pedro de Atacama. It is a high mountain range in Chile's Second Region (Andes Mountains), at the foot of TOCO hill, at an altitude of 5,148m and with the following coordinates 2295870° S and 6778789° W (UTM coordinates, North 7.406.891; East 624.471). It is near the site where the ALMA radio telescope is located in Chajnantor, Chile (image N°1).

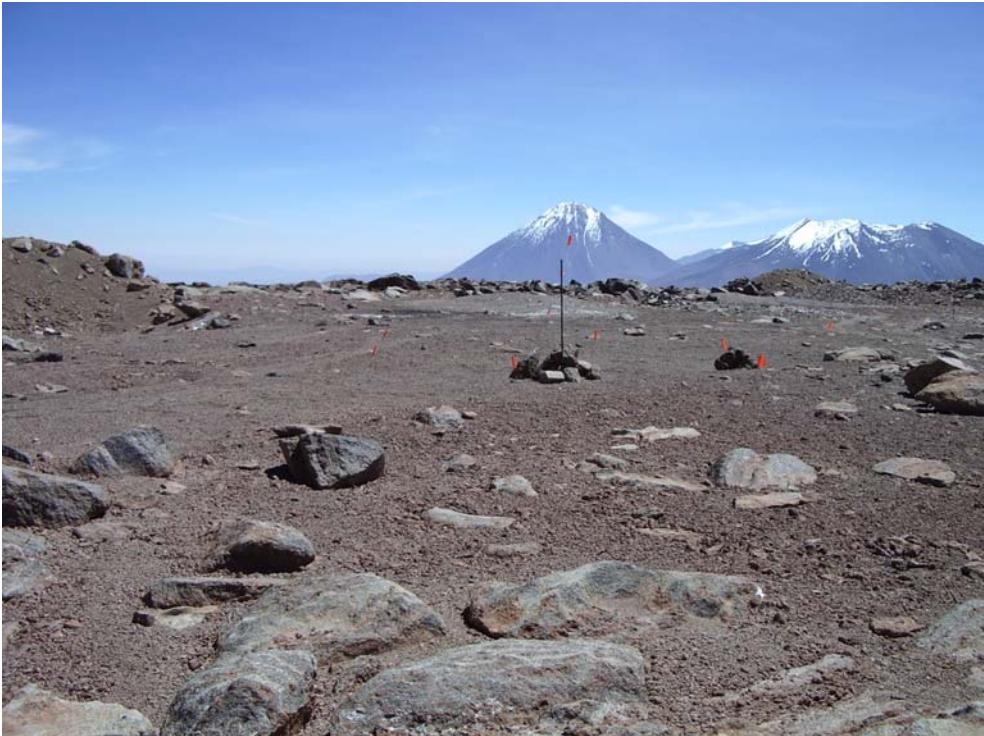
**Image N°2:** Project site

Image N° 2 that follows, shows the project site, that was previously marked before drilling works starts with flags from the center point (which correspond at the point initially suggested by AMEC for the foundation) and marking circumferences toward the borders, with 29 meters diameter.

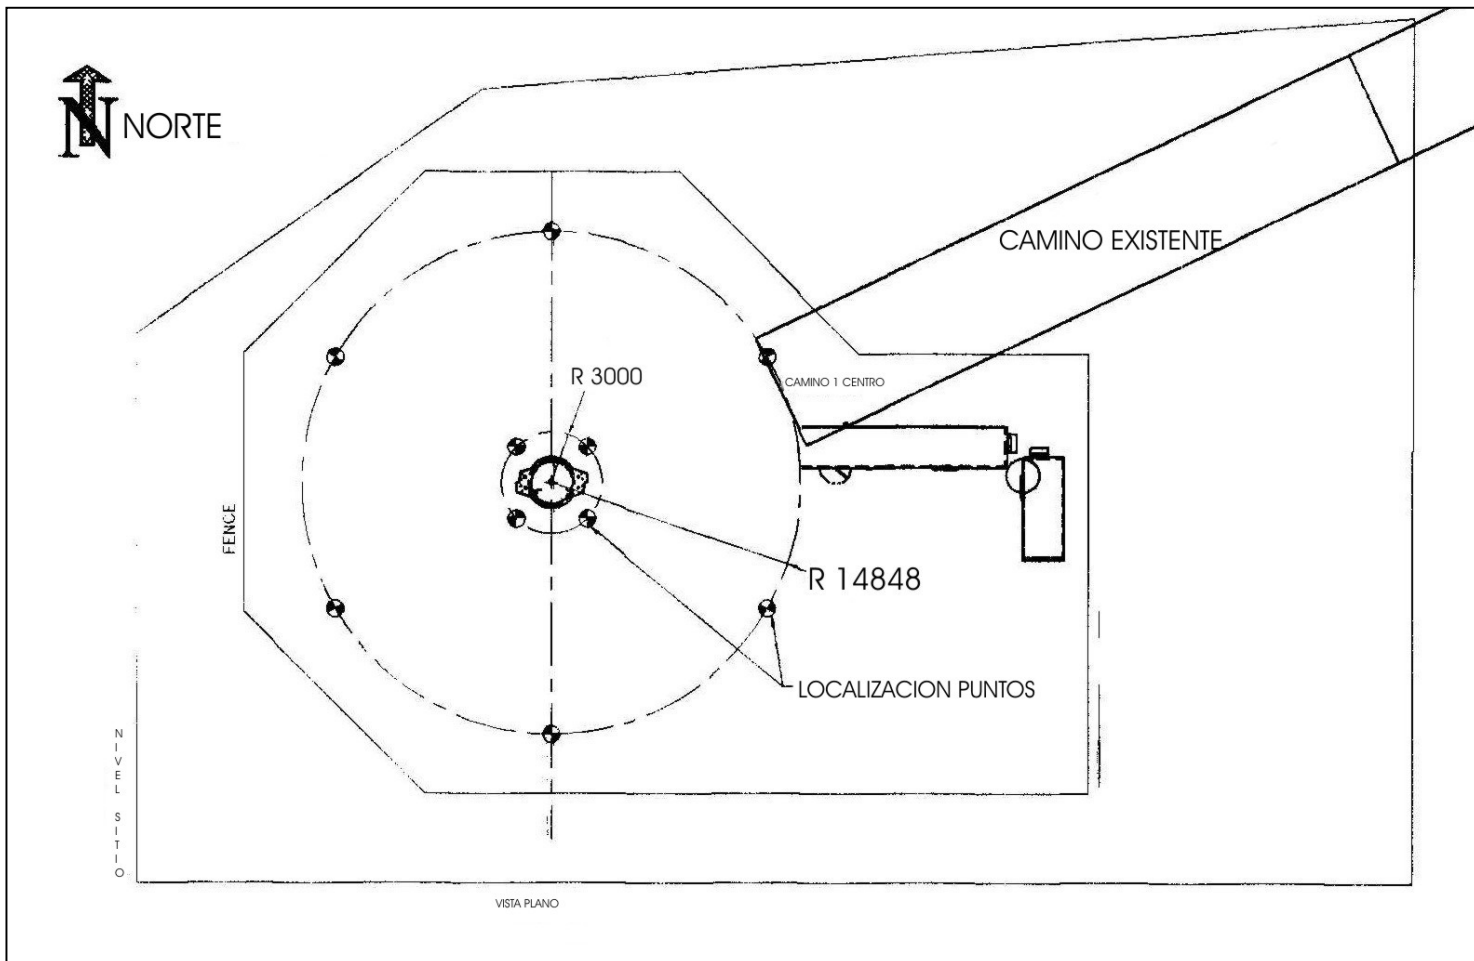
**Image N°3:** Initial location of points to be drilled

Geominas Limitada drilled eight holes, each one of 7.8 meters depth, in average. The exactly location of the perforations were determined by means of information supply by AMEC (image N°3 following).
